20 February 2020

Reference: 0042525

Subject: North Penn Area 2 Superfund Site
Progress Report for July – December 2019

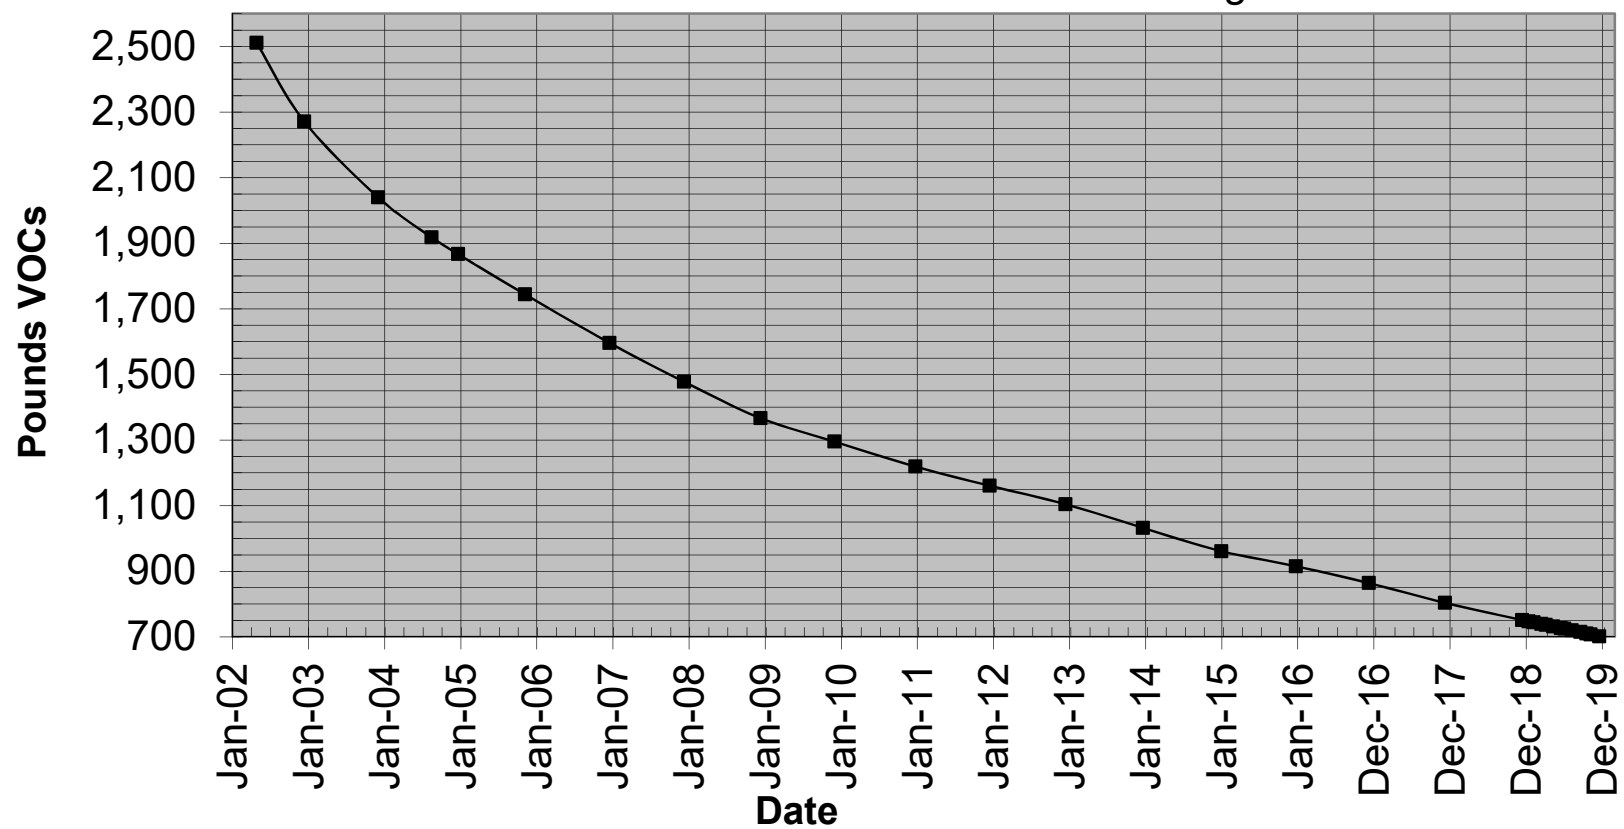
Figure A
North Penn Area 2 Superfund Site
Estimated Pounds VOCs Remaining

3. Tables 3 through 5 summarize the recent performance data for recovery wells PW-3 and MW-2S. The most recent estimate of the amount of VOCs remaining in the bedrock groundwater is depicted on Figure A.
